The POWER of position

by Robert Kaplan
Predictive Maintenance Engineer
Florida Power & Light
St. Lucie Plant

Vibration levels were not the indicator of degraded turbine generator bearings at Florida Power & Light's St. Lucie Plant. Although the vibration diagnostics indicated that a problem was developing, vibration levels did not increase to unacceptable levels. Shaft position information, available through Bently Nevada proximity probes, provided the supporting information that convinced plant personnel to inspect the damaged bearings.

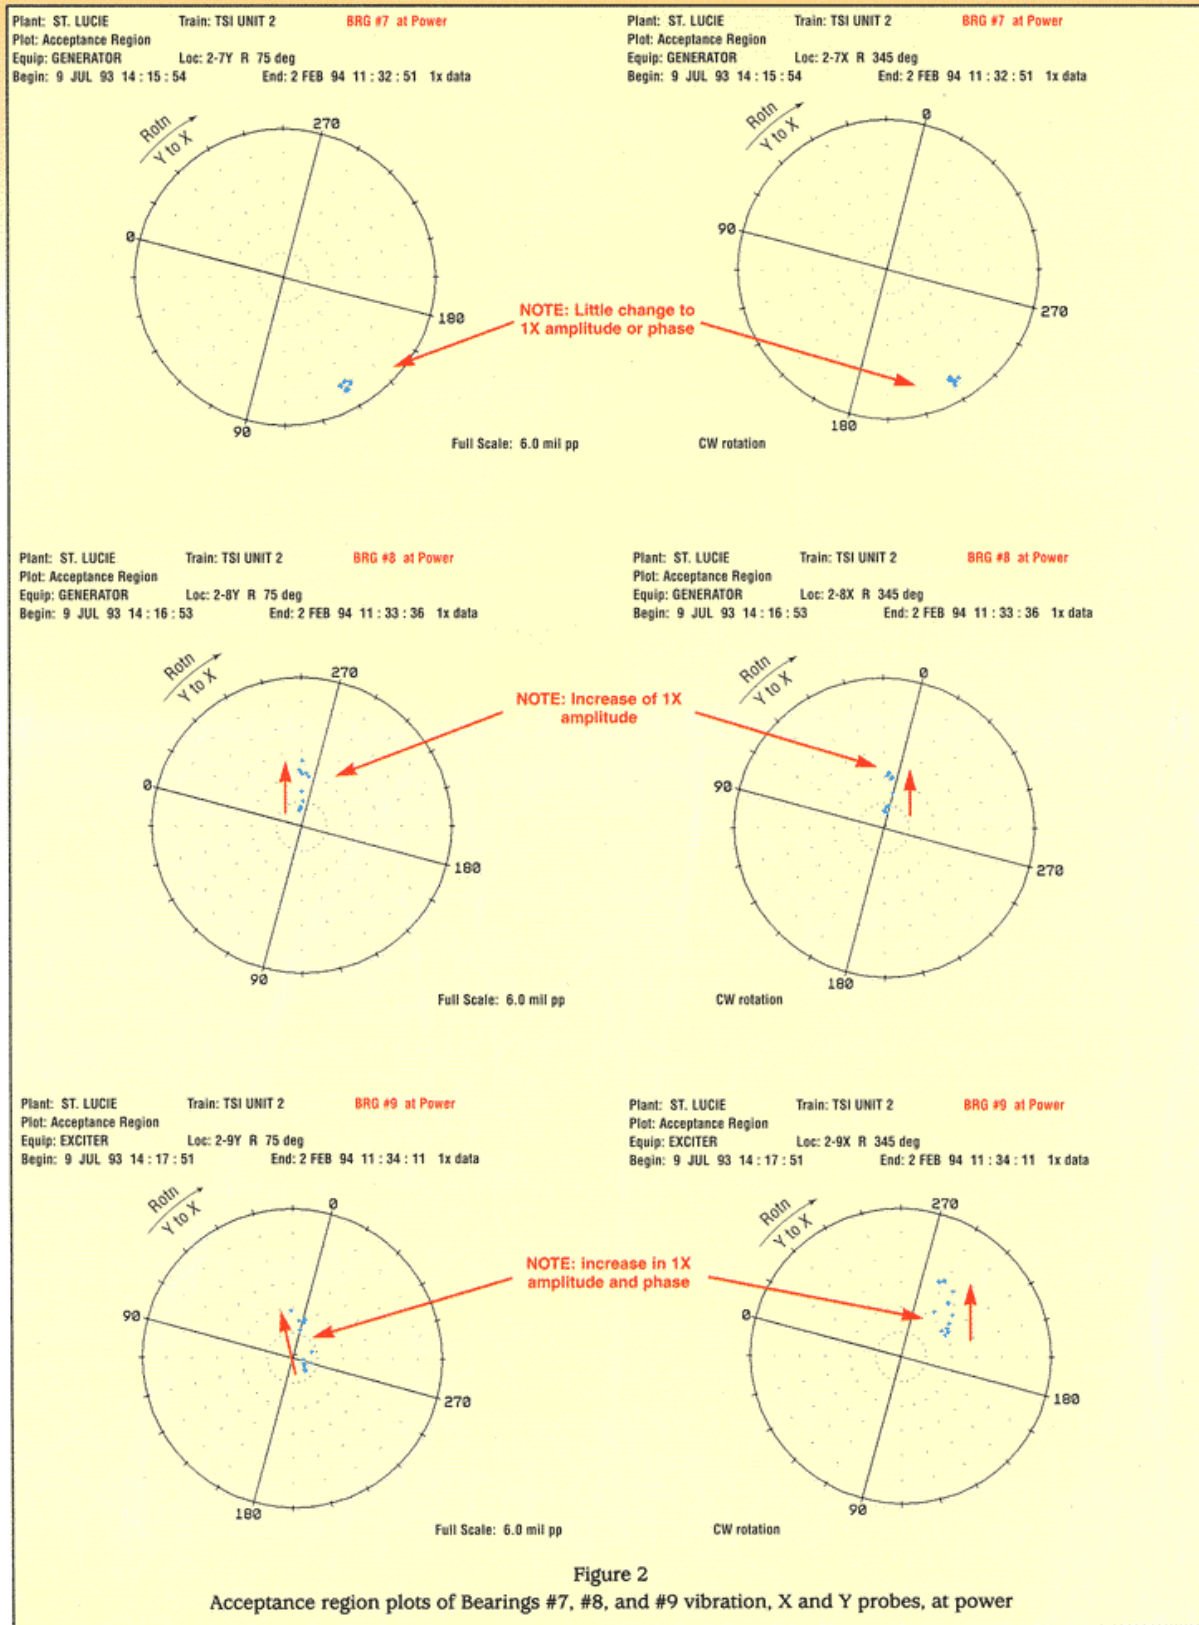
On November 2, Unit 2 was manually shut down for a short time to correct a temperature excursion. Analysis of vibration data routinely taken after restart identified some changes to the vibration signature of the exciter (Table 1 and Figure 2).

- 1) Bearing #7: The 1X relative vibration patterns did not significantly change.
- 2) Bearing #8: The 1X relative vibration levels increased 1.9 mils to 2.6 mil pp and stabilized at this increased level. The 1X phase angles didn't significantly change. *More significantly, the shaft position had immediately shifted 6 mils horizontally.*
- 3) Bearing #9: The 1X relative vibration levels increased by 1.2 mil pp over the next 15 weeks to 3.4 mil pp.

The 1X phase angle of the Y and X vibration signals increased 31 degrees and 108 degrees, respectively. *The shaft position also shifted 6 mils, but in the opposite direction from Bearing #8, over the next several weeks (Figure 3).*

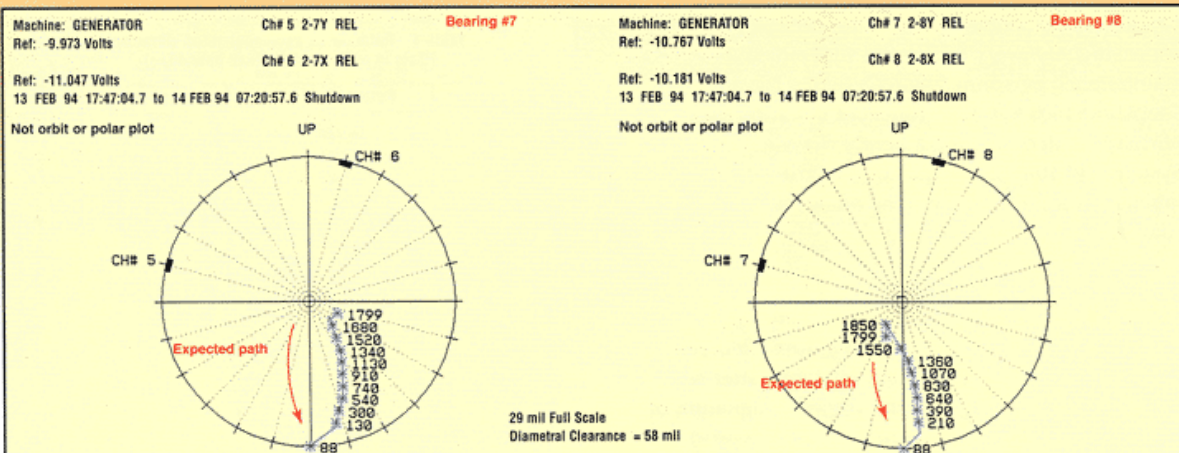
Figure 4a
Shaft centerline plot of Bearings #7 and #8 coastdown with damaged bearing

The shaft centerline coastdown path (Bearings #7 and #8) approached the turning gear position from the wrong quadrant. (Figure 4a). This pattern was not seen on previous coastdowns or startups (Figure 4b), and was a good indication that bearing damage had occurred. The damaged bearing surface modified the direction of the hydrodynamic forces in the bearing, which resulted in a different shaft position angle.

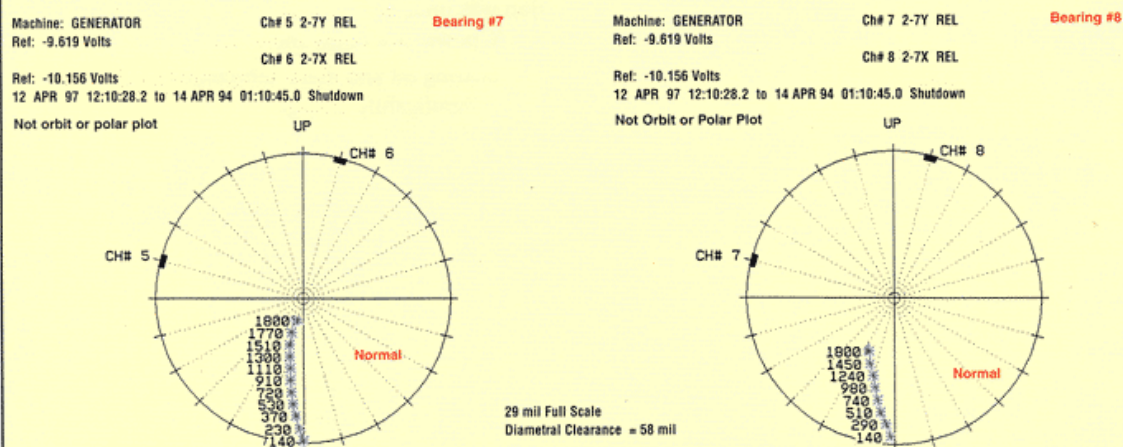
Figure 4b
Shaft centerline plot of Bearings #7 and #8 normal coastdown with undamaged bearings

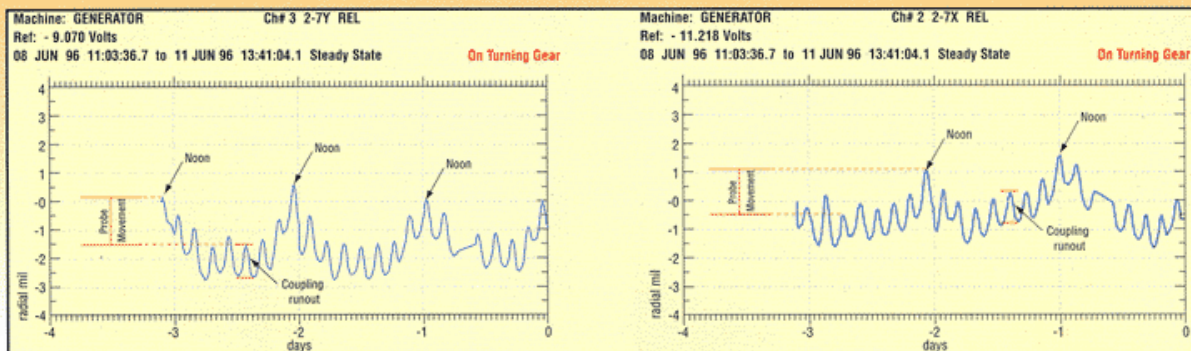
Figure 5a
Normal flexure, on turning gear, of generator shell due to hydrogen cooler.

In contrast, trended gap voltage readings showed that the generator normally goes through a 1 to 2 mil flexure during a 24-hour cycle, both on turning gear and in normal operation, peaking at midnight and returning to normal at noon (Figure 5a and 5b).

The likely scenario that explains this data is that the hydrogen coolers, located on the top of the generator, cool the upper shell more than the lower shell. This should create an upward flexure that would lift the probes away from the shaft (as the generator bearings are internal, these probes are mounted to the generator shell). Later, the uneven temperature distribution would be alleviated by thermal heating from the sun and the apparent shaft position would return to normal.

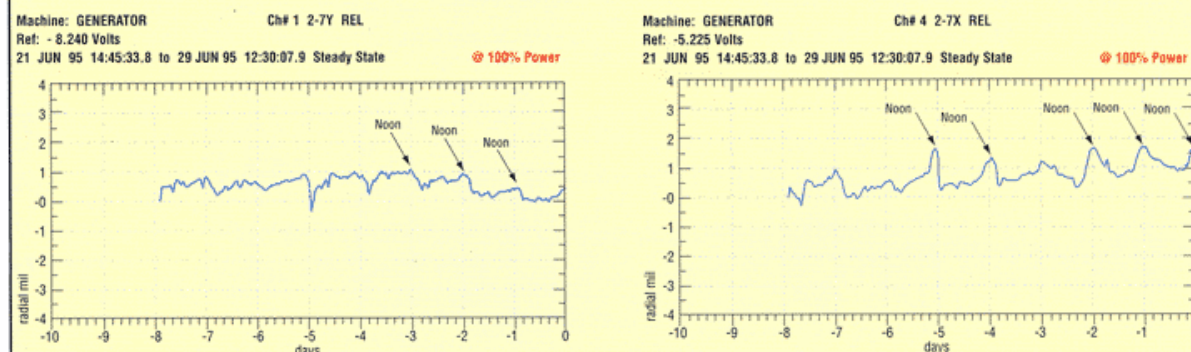
Figure 5b
Normal flexure, at 100% power, of generator shell due to hydrogen cooler.

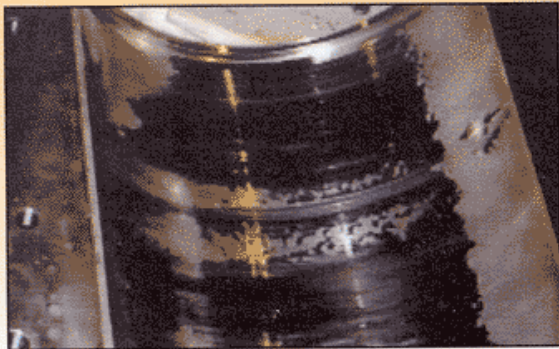
The available machinery data indicated a high probability of degradation at Bearings #7, #8 and #9, and the decision was made to perform a bearing inspection. Each bearing was found to be wiped. The increased clearances led to the changes in position documented in the steady state and transient vibration

information. In addition, Bearing #7 had ingested a small washer, which gouged a chunk out of the babbitt material, and then became imbedded (Photos 1 & 2).
